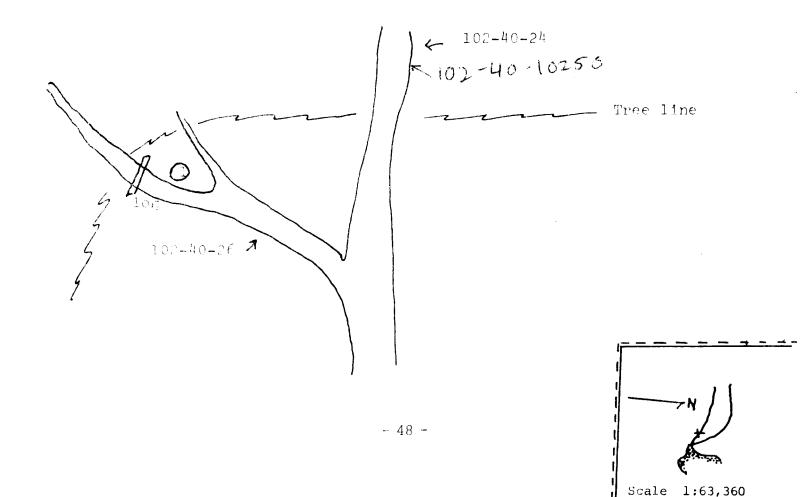
Very small stream - good I.T. gravel with approximately 60 yards of available spawning area. A few unidentified fish bones seen plus 1 chum carcass. Spreads out in lower IT. Has a common mouth with stream 102-40-24. Stream banks stable. 1/2 tide and flooding. Overcast - rain. Stream flow normal. 90% usable spawning area.
